# **Nuclear Safety Basics**

Introduction to the goals and terminology of Nuclear Safety

# Nuclear Power Generation

Introduction to Nuclear Energy and Nuclear Power Plants

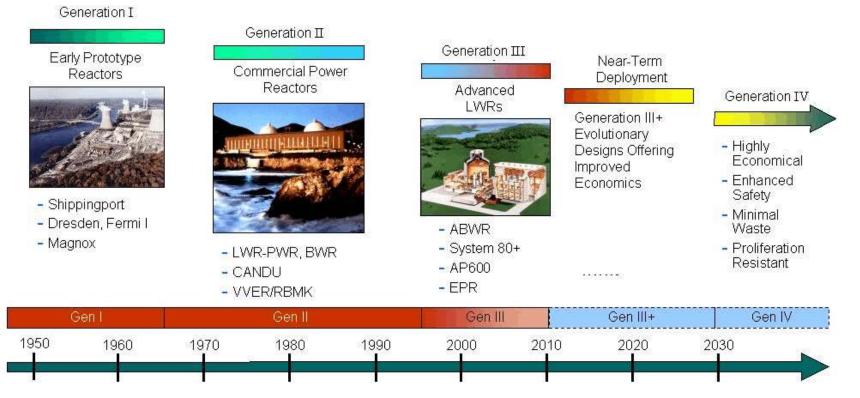
### Nuclear Reactor History and Generations

- Generation II: class of commercial reactors built up to the end of the 1990s
- Generation III: development of Gen. II designs, improved fuel technology, superior thermal efficiency, passive safety systems, and standardized design
- Generation IV: nuclear reactor designs currently being researched, not expected to be available for commercial construction before 2030

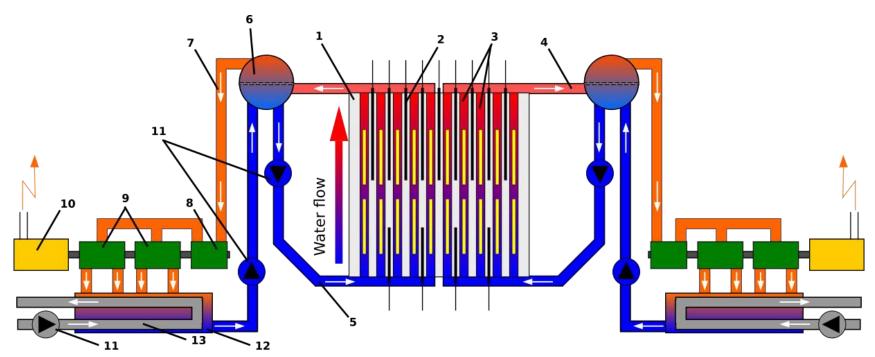
### Schematic diagram of the RBMK reactor

#### Legend :

- 1. Graphite moderated reactor core
- 2. Control rods
- 3. Pressure channels with fuel rods
- Water/steam mixture
- 5. Water
- 6. Water/steam separator
- 7. Steam inlet

Major differences between the Chernobyl RBMK and the LWR:1. The use of a graphite moderator in a water cooled reactor.2. A positive steam void coefficient that made the power excursion possible, which blew the reactor vessel.

- A peculiarity of the design of the control rods caused a dramatic power surge as they were inserted into the reactor
    - The RBMK reactor has a positive void coefficient due to deficiencies in the design

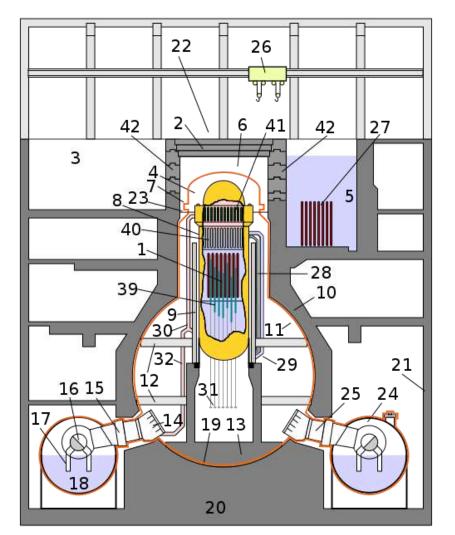
Cross-section sketch of a typical BWR Mark I containment, as used in Units 1 to 5.

The reactor core (1) consists of fuel rods and moderator rods (39) which are moved in and out by the device (31). Around the pressure vessel (8), there is an outer containment (19) which is closed by a concrete plug (2). When fuel rods are moved in or out, the crane (26) will move this plug to the pool for facilities (3). Steam from the dry well (11) can move to the wet well (24) through jet nozzles (14) to condense there (18). In the spent fuel pool (5), the used fuel rods (27) are stored.
